Research Report
UKTRP-84-28

JACKSON PURCHASE PARKWAY PAVEMENT STUDY

James H. Havens
Associate Director

Kentucky Transportation Research Program
College of Engineering
University of Kentucky

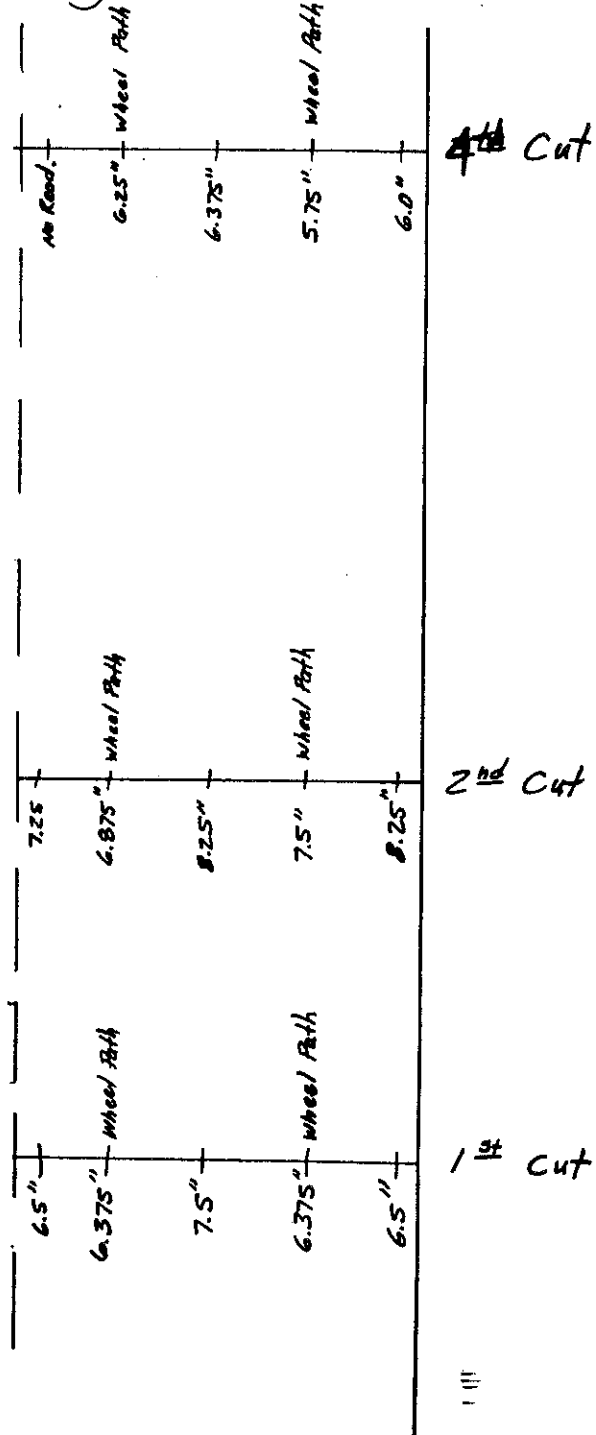
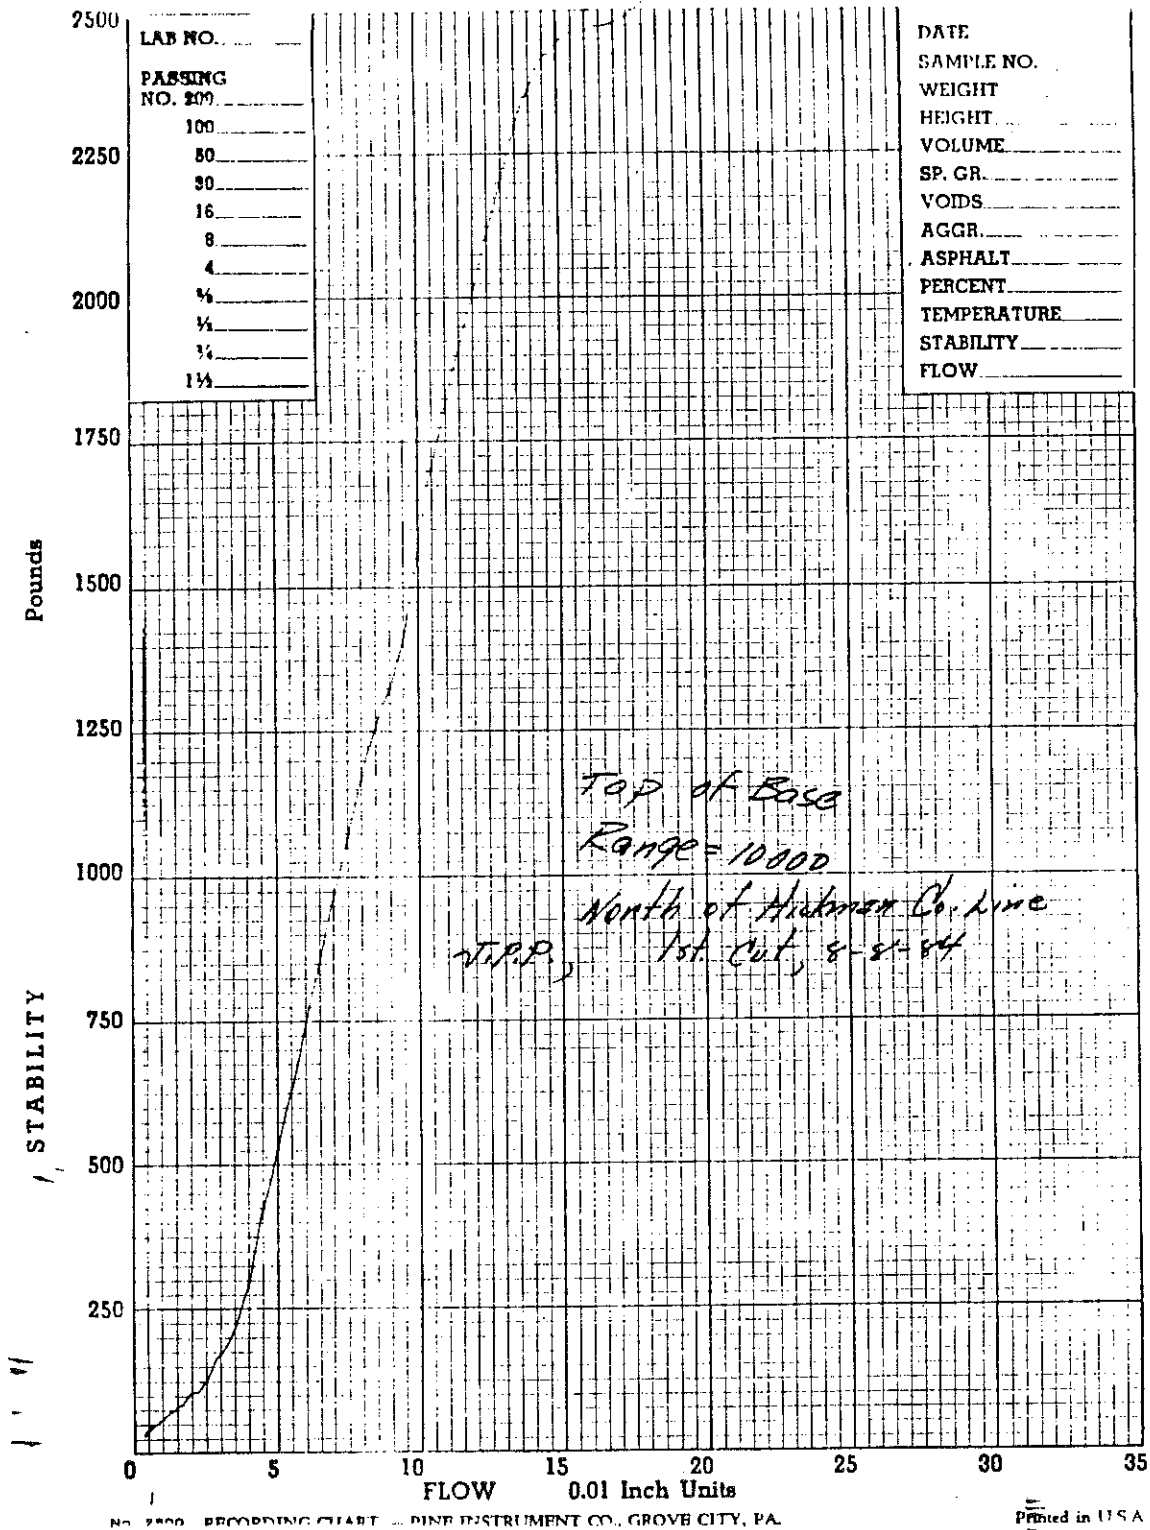
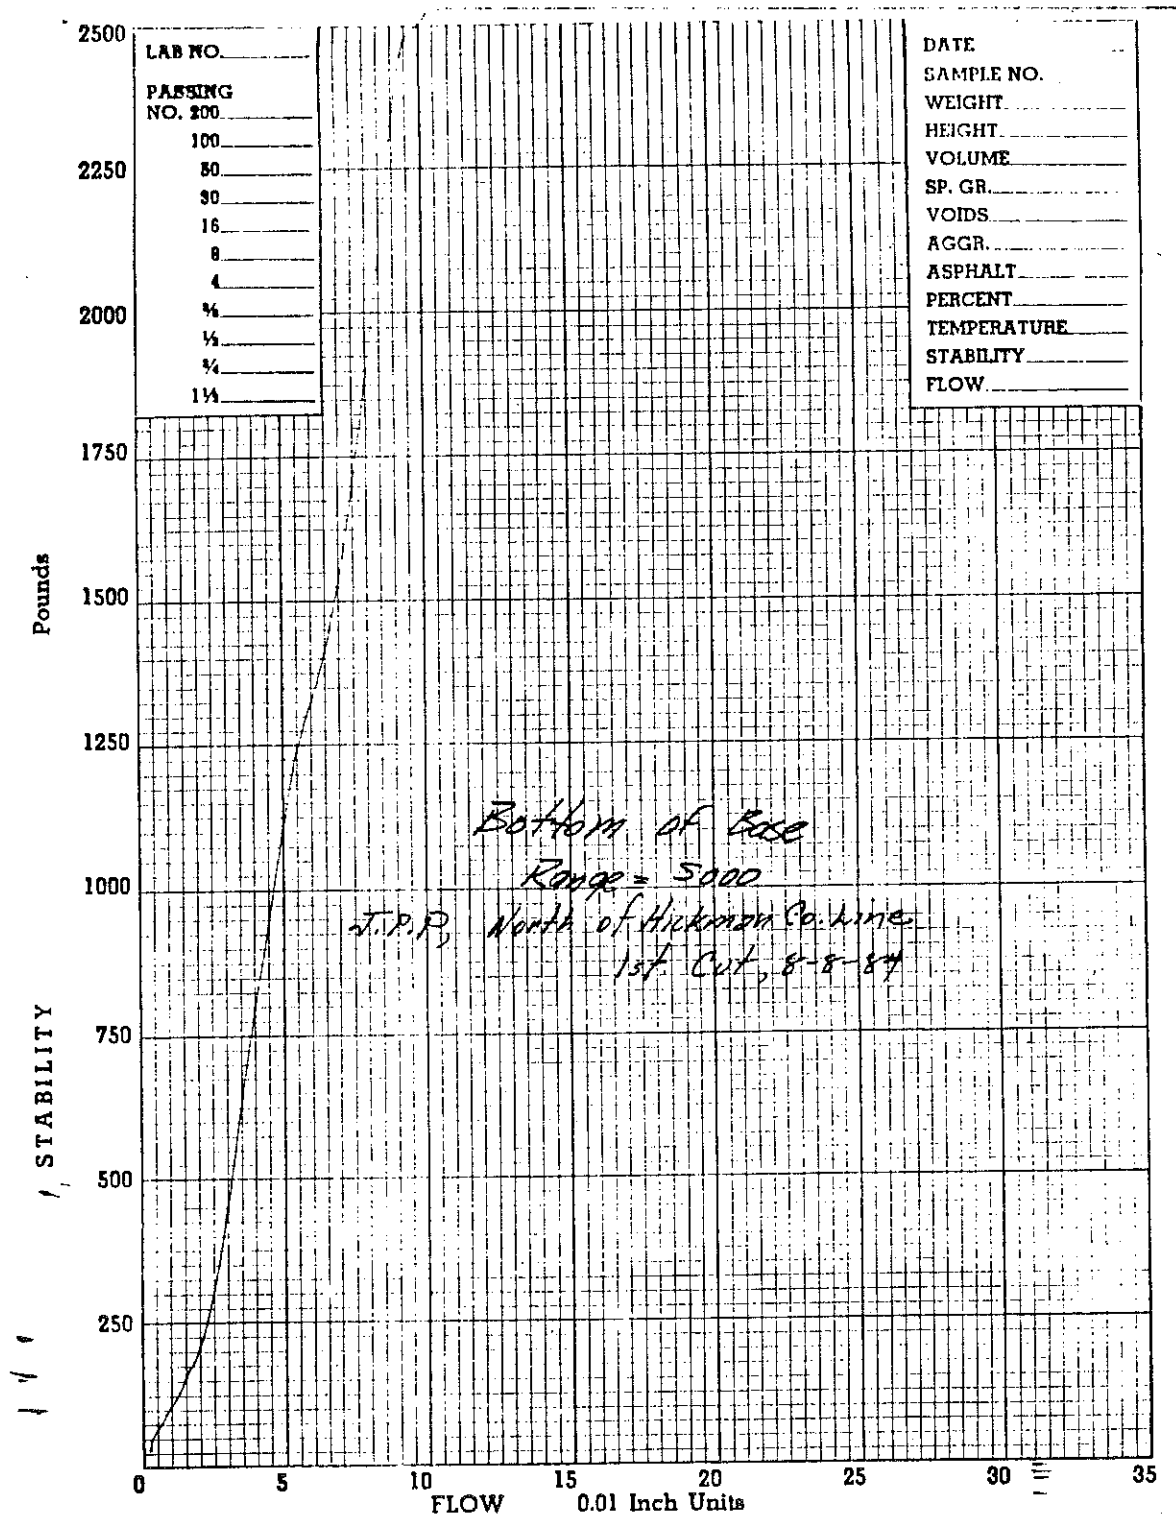
Site 1. Immediately North of Graves-Hickman County Line; Chosen as Control Site; Bituminous Concrete Composed of Crushed Limestone and Partially Crushed Gravel; August 8, 1984.
